Investigation of Degradation Mechanisms of Cr-coated Zirconium Alloy Cladding in Reactivity-Initiated Accident (RIA)

Data Gaps for Response of ATF Cr-coated Zr-alloy Cladding under Power Transient Conditions (RIA)

Investigation of thermal, mechanical, and irradiation response of <u>Cr-coated Zr-alloy claddings</u> (Cold spray, PVD) under RIA conditions, <u>in comparison to uncoated Zr-alloy cladding</u> to demonstrate various cladding failure modes at the later phase transient (post-DNB)

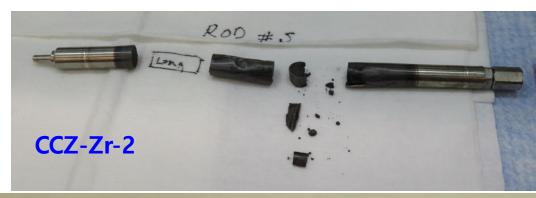
Visual observation for post-irradiation CCZ-Zr-3 & CCZ-Zr-2

- ✤ CCZ-Zr-3
 - Ballooning and burst was observed showing a burst opening
- ♦ CCZ-Zr-2
 - Severe oxidation was observed showing very brittle characteristic
 - Unclear if the ballooning and burst was occurred
