Integral Fuel Rod Real-Time Wireless Sensor & Transmitter Irradiation Test and Post Irradiation Examination

4/17/2024

WIRE-21: HFIR's most highly instrumented experiment

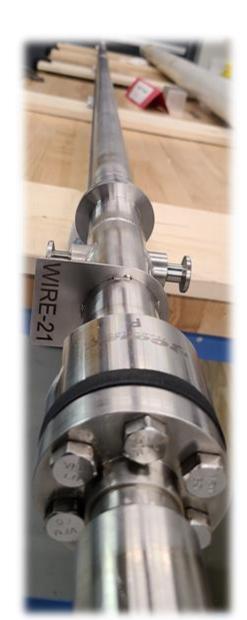
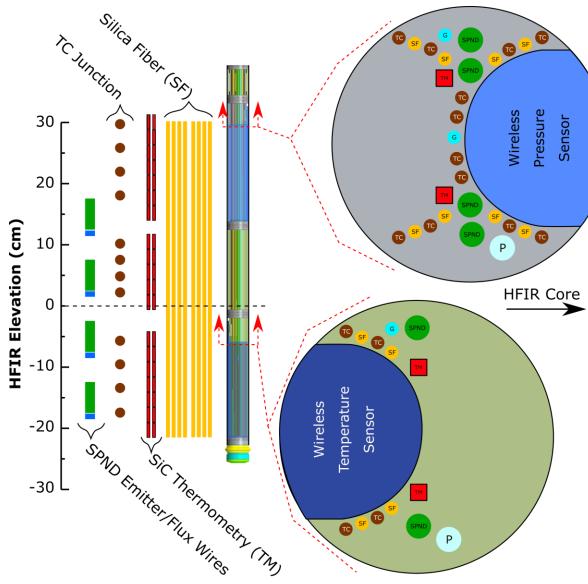
- Primary goal: Irradiate WEC's wireless temperature & pressure sensors at LWR temperatures
- Broader goal: Develop a platform for economical, accelerated testing of advanced sensors
 - Thermocouples (14)
 - Distributed fiber optic temperature sensors (8)
 - Self-powered neutron detectors (4)
 - Passive SiC temperature monitors (38) and flux wires (4)
- Completed 3 HFIR cycles
 - $\sim 3 \times 10^{21} \, n_{\text{fast}} / \text{cm}^2$
 - ~6×10²¹ $n_{thermal}/cm^2$

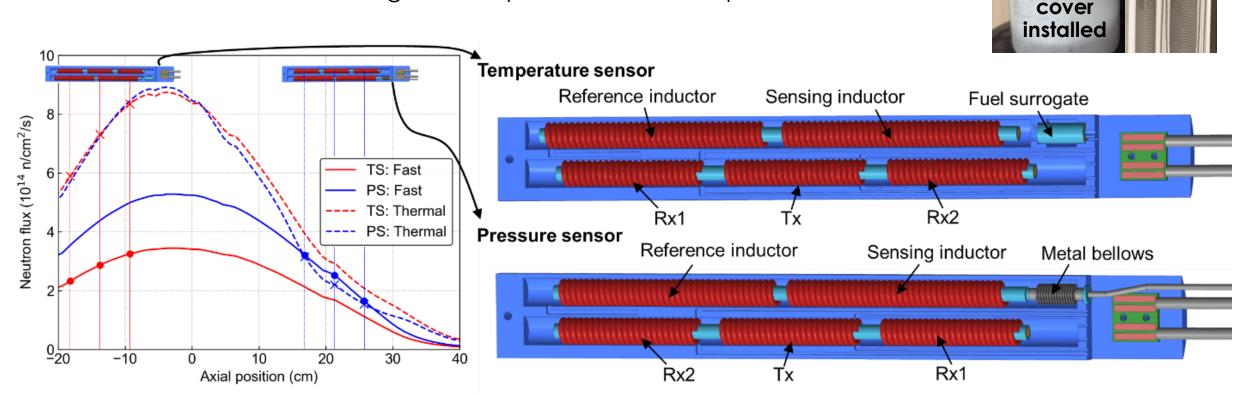
WEC's inductively coupled sensor technology

- Wireless transmission to passive circuit with varying resistance (RTD on fuel surrogate) or inductance (core driven by metal bellows)
- Reference inductors account for effects of radiation, inductor temperatures
- Similar fast neutron flux for both sensors ($\sim 1.6-3.3 \times 10^{14}$ n/cm²/s)
- Thermal neutron flux much larger in temperature sensor vs. pressure sensor

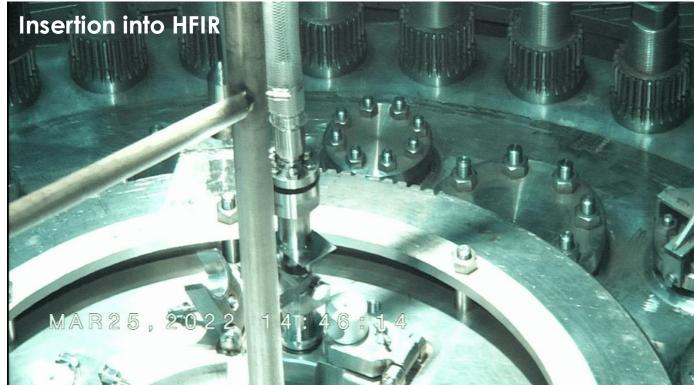
Operation

- 3 HFIR cycles completed, 75 effective full power days
- Peak neutron fluence
 - Fast (E>0.1 MeV): 3×10^{21} n/cm²
 - Thermal (E<1 eV): 6×10^{21} n/cm²
- Achieved target of ~300–400°C
 - All 10 sheathed TCs survived
 - 2 exposed TCs inside WEC sensors failed
 - Lower temperatures above active fueled region (>25 cm)
 - Initial increases thought to be caused by compaction of graphite holders

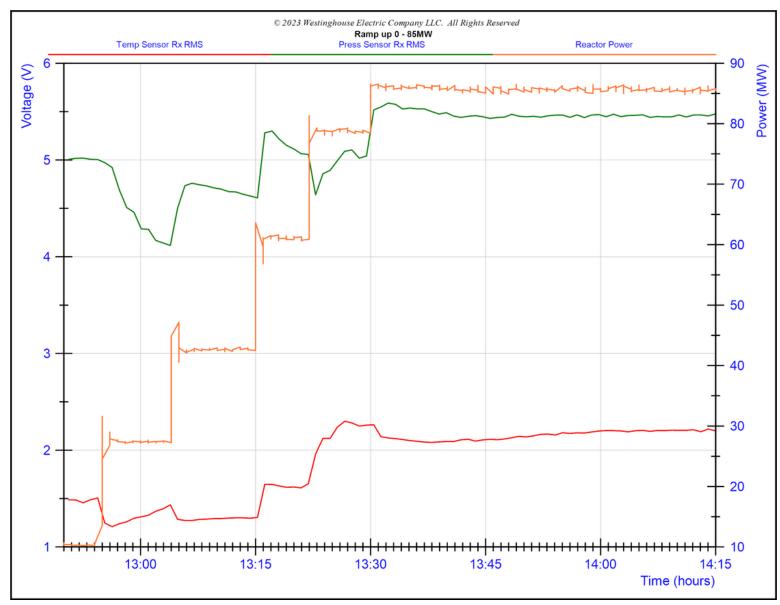
WEC's sensor response during 1st HFIR cycle

- Sensors responded during ascent to full power
- Response not exactly as expected but stabilized at steady state

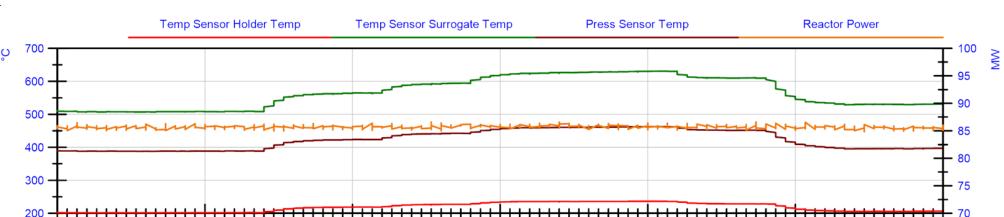
WEC's response during pressure/temperature transients

Signal did not track exactly with thermocouple

Clearly some hysteresis in both sensor signals

- Temperature: 2 to 6.5 V

Pressure: 5.5 to 4.5 V

Pressure sensor did not respond at all to changes in pressure

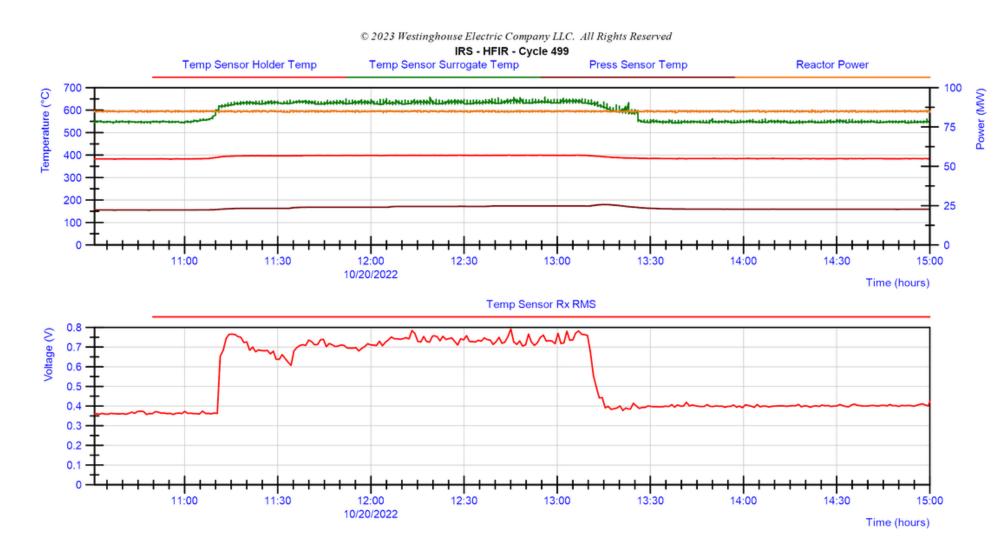
Temperature transient during 2nd HFIR cycle

- Signals dropped relatively quickly during the first cycle
 - 6.5 V after 1st cycle transient to 0.35 V
- Sensor still responded as expected to a temperature transient performed in the 2nd cycle

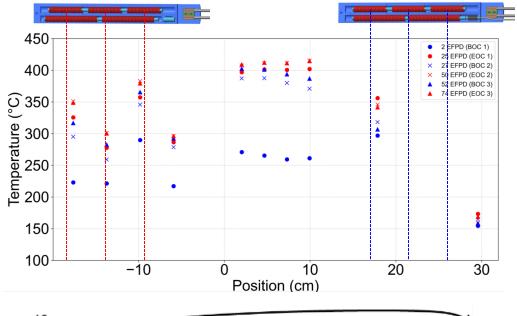
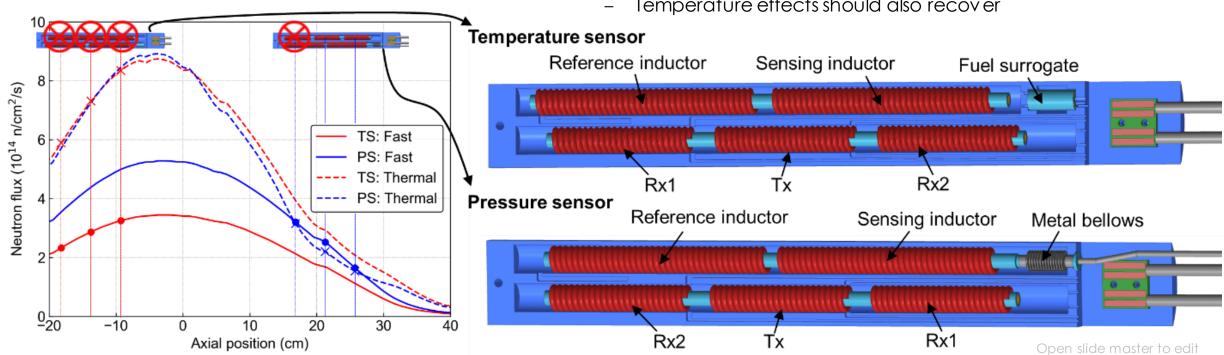
WEC Sensor Inductance Evolutions

~10X reductions in inductance within 2 days, with minimal (~10%) changes in resistance

- Not observed in previous MITR tests at lower flux
- More significant in inductors with higher thermal flux
- Similar fast flux in all inductors
- Recovery after reactor scram only observed in 2 inductors tested at lower thermal flux
- All except Rx1 in PS (\sim 25 cm, \sim 150°C) ran at \sim 200– 300°C during initial drop in inductance
 - Temperature effects should also recover

- WEC sensors performed as expected during installation and startup
 - Change in inductance, due to degradation in permeability of ferromagnetic rod, during the first few hours of testing was greater than expected, reducing coupling sensitivity between transceiver and sensor
 - Not observed in MITR or Halden Reactor (lower neutron flux)
 - Plan to investigate potential degradation mechanisms (transmutation vs. displacement damage)
- Initial fiber optic results show very strong signals but prohibitively large drift
 - Fiber transmission and FBG performance strongly depend on fiber dopants
 - Ongoing ASI efforts to understand effects of fiber coating on observed drift
- SPND and thermocouple data will be useful to compare with passive measurements (SiC temperature monitors, activation wires) under ASI

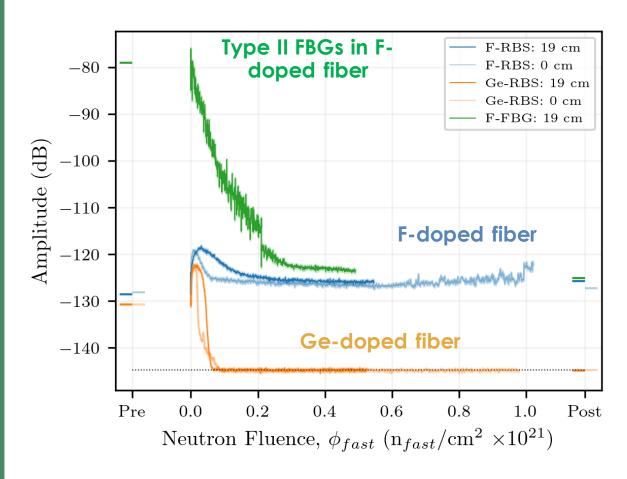
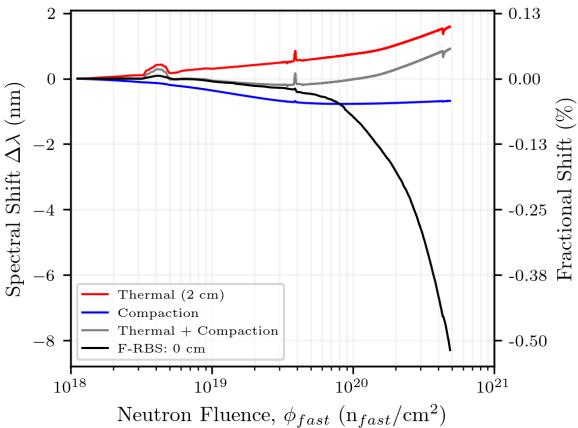
Results: Good and Bad News for F-doped Fibers

Drastic differences in reflected signal amplitudes at high neutron fluence

Measured spectral shifts (temperatures) deviate from thermal + compaction models at high neutron fluence (suspected fiber coating effect)

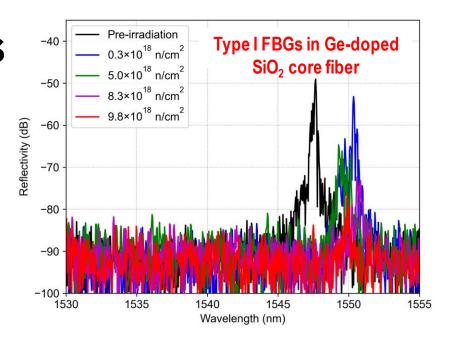
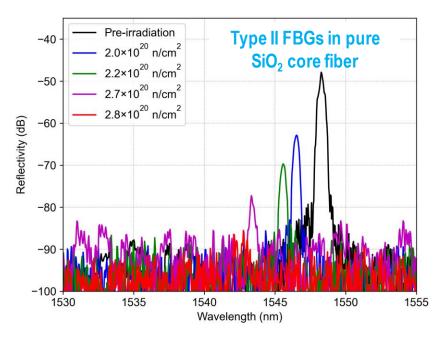
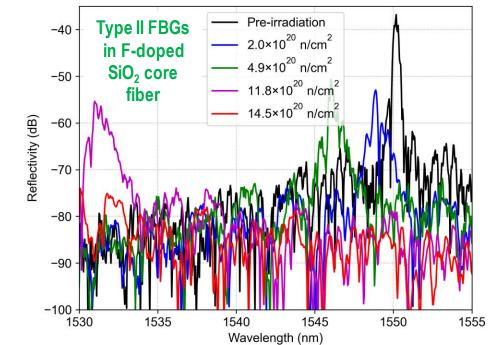
Results: Gratings

Core dopants and FBG type have strong effect on FBG stability

- Type I FBGs in Gedoped core fiber erased within 2 days of irradiation (not shown)
- Type II FBGs in pure SiO₂ core fiber attenuated >40 dB during first cycle
- Type II FBGs in F-doped core fiber survived entire experiment but still drifted significantly
